**WASTEWATER TREATMENT FACILITY
AND SEWER COLLECTION SYSTEM
CLIMATE ADAPTATION PLAN**
for the
WELLS SANITARY DISTRICT
Wells, Maine

**WASTEWATER TREATMENT FACILITY & SEWER COLLECTION SYSTEM
CLIMATE ADAPTATION PLAN**

JANUARY 2020

**Wright-Pierce
75 Washington Avenue, Suite 202
Portland, ME 04101**

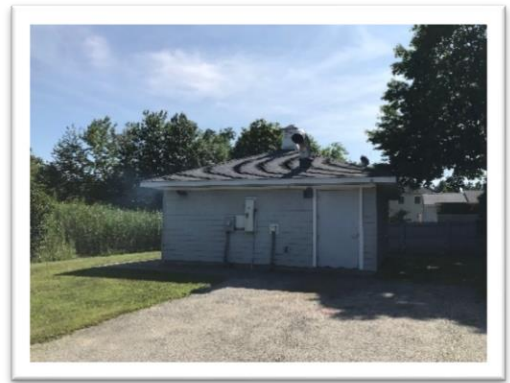
PUMP STATION 1

- Pump motors located in intermediate level below grade on drywell side of pump station.

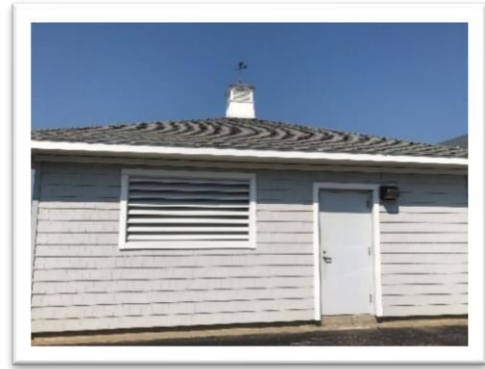
PUMP STATION 2

- Underground electrical feed experienced historical flooding. Main feed conduits were replaced and resealed in 2016.
- Station's electrical conduit and panels appear to be original to the station construction. Not clear if they are NEMA-rated explosion proof and/or gas tight.

- Pump motors located in intermediate level below grade on drywell side of pump station.

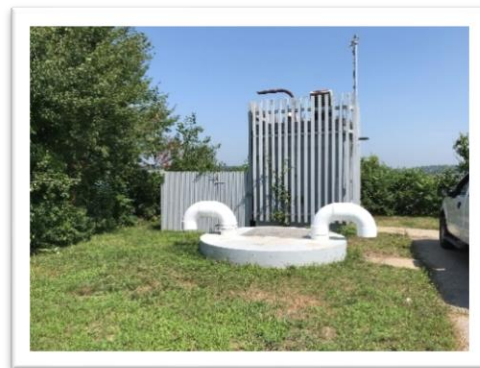
PUMP STATION 3

- Station is located near salt marsh but significantly elevated above it.
- Main electrical service fed from underground conduit.
- Electrical conduit penetrations in upper and intermediate levels are not sealed or watertight.
- Electrical conduit and panels appear to be original to the station construction. Not clear if they are NEMA-rated explosion proof and/or gas tight.

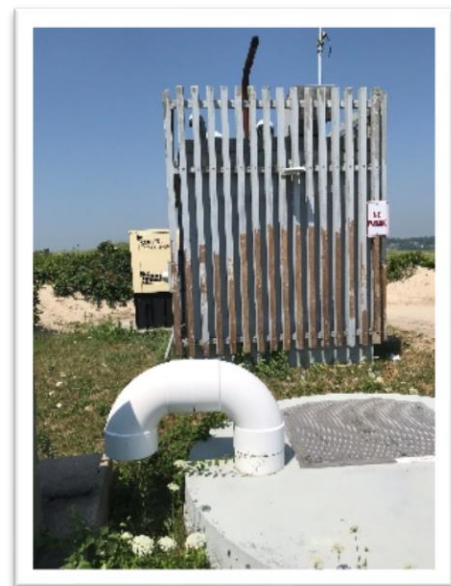
PUMP STATION 4

- Station is located near tidal river and salt marsh, but no historical flooding of the pump station has been observed by operators in the past 30 years.
- Local power transformer is located next to station on 12-inch concrete pad.
- Wetwell is very close to local transformer. Wetwell flooding and off-gassing could be a risk to transformer.
- Main power feed is from underground electrical conduit. Seals appear to be in good condition.
- Electrical conduit and panels appear to be original to the station construction. Not clear if they are NEMA-rated explosion proof and/or gas tight.

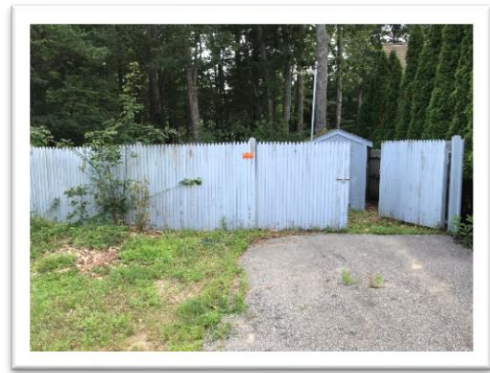
PUMP STATION 5

- Rust has formed on the top of the control box on the third intermediate level, possibly from water leaking down from upper levels through unsealed conduit penetrations.

- Station is equipped with an indoor 15-kW stand-by propane generator inside a wooden shed.
- Generator is elevated about 1 foot from grade elevation.
- The generator is original to the pump station construction.
- Large trees overhang pump station property.
- No nearby waterbodies present.
- Adjacent property is part of federal wildlife refuge.
- Roof of pump station hut must be unbolted removed to perform routine pump maintenance tasks.
- Station has radio telemetry equipment located on top of the generator hut building.

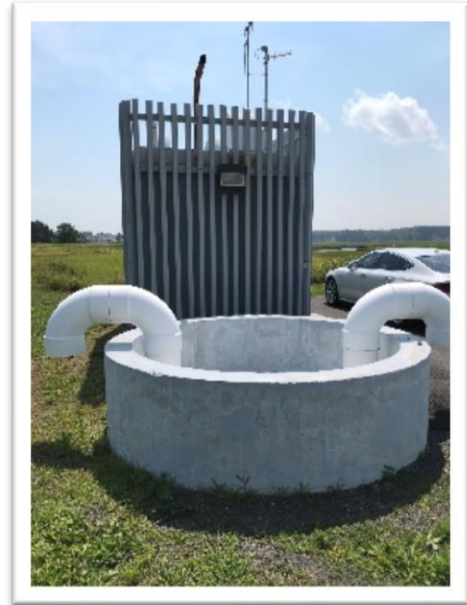
PUMP STATION 6

- Wetwell structure is equipped with concrete wall 26 inches above grade to prevent flooding.
- Station building has removable wooden flood barriers for entrance door.
- Electrical conduit and panels appear to be original to the station construction. Not clear if they are NEMA-rated explosion proof and/or gas tight.
- Main power feed is from underground electrical conduit. Seals appear to be in good condition.
- The bottom of the main breaker panel in the pump station building is 20 inches above finished floor elevation.
- Station is equipped with an indoor 62-kW standby diesel power generator elevated 6 inches from finished floor elevation on the first floor of the generator building.

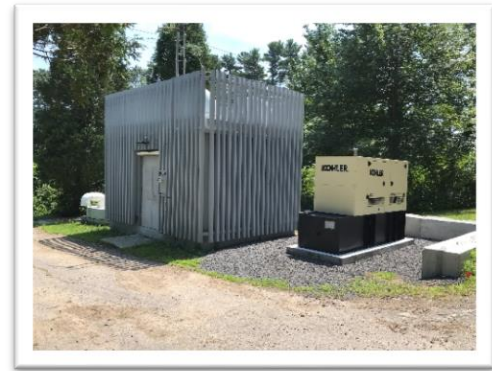
PUMP STATION 7

- Electrical conduit and panels appear to be original to the station construction. Not clear if they are NEMA-rated explosion proof and/or gas tight.
- Main power feed is from underground electrical conduit. Seals appear to be in good condition.

- Station has radio telemetry equipment located on top of pump station building.
- Station had sump pump located on bottom floor with pump motors.
- Station is equipped with back-up mechanical float switch for emergency override of local disconnect switch to shut-off of pump motors.

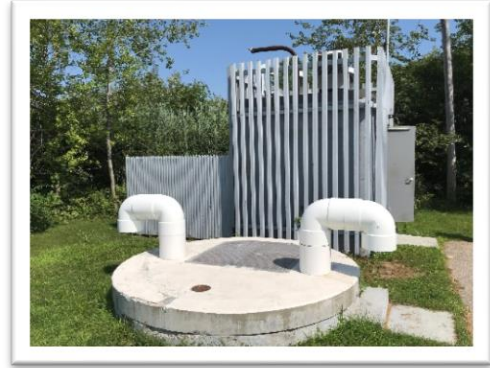
PUMP STATION 8

- Main power feed is from underground electrical conduit. Seals appear to be in good condition.
- The bottom of the main breaker panel in the pump station building is 26 inches above finished floor elevation.

- Station has sump pump located on bottom floor with pump motors.
- Station is equipped with back-up mechanical float switch for emergency override of local disconnect switch to shut-off of pump motors.

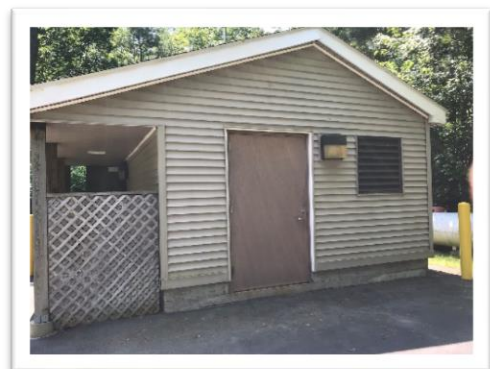
PUMP STATION 9

- Main power feed is from underground electrical conduit. Seals appear to be in good condition.
- The bottom of the main breaker panel in the pump station building is 22 inches above finished floor elevation.
- Station has radio telemetry equipment located on top of pump station building.
- Station is equipped with propane-driven standby power engine located in the pump station building.
- The standby power engine's propane tank is located outdoors and is elevated on concrete cinder blocks.

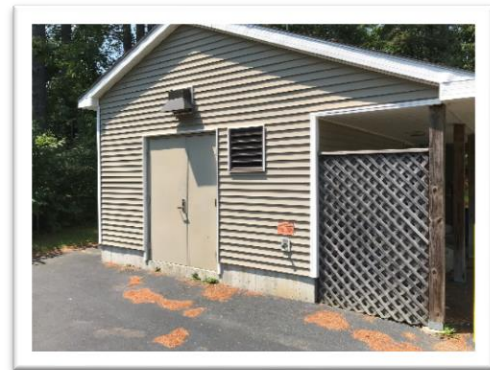
PUMP STATION 10

- Main power feed is from underground electrical conduit. Seals appear to be in good condition.
- The bottom the main breaker panel in the pump station building is 12 inches above finished floor elevation.
- Station is equipped with propane-driven standby power engine located in the pump station building.
- The standby power engine's propane tank is located outdoors and is at grade.
